BASTIÓN DE SAN DIEGO

INTRAMUROS ADMINISTRATION
MINISTRY OF HUMAN SETTLEMENTS

The conservation of Bastión de San Diego began on March 17, 1979. This initial effort to clear the structure of vegetation and waste led to the discovery of interesting architectural features, many of them previously unrecorded and photographed.

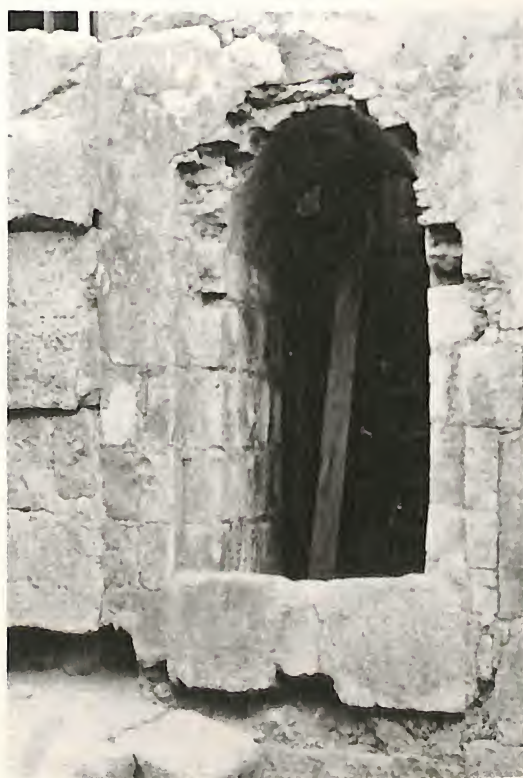
Figure 17. In the original structure, this narrow archway led to the patio. When the outer patio was backfilled with some 1.56 meters of sand, part of this doorway was blocked. Marks on the door frame indicate that it was fitted with a door.

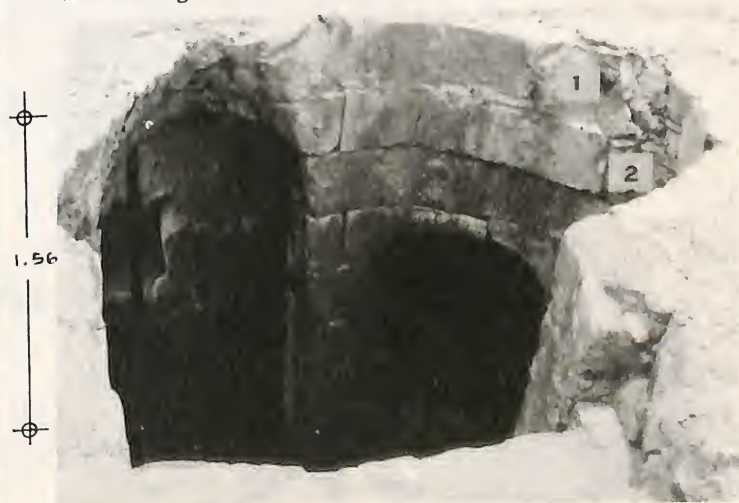
Figure 18. A view of the stairwell. Acroposts support some of the loose stones of the structure. Numbers one and two indicate missing stone members of the original winding staircase.

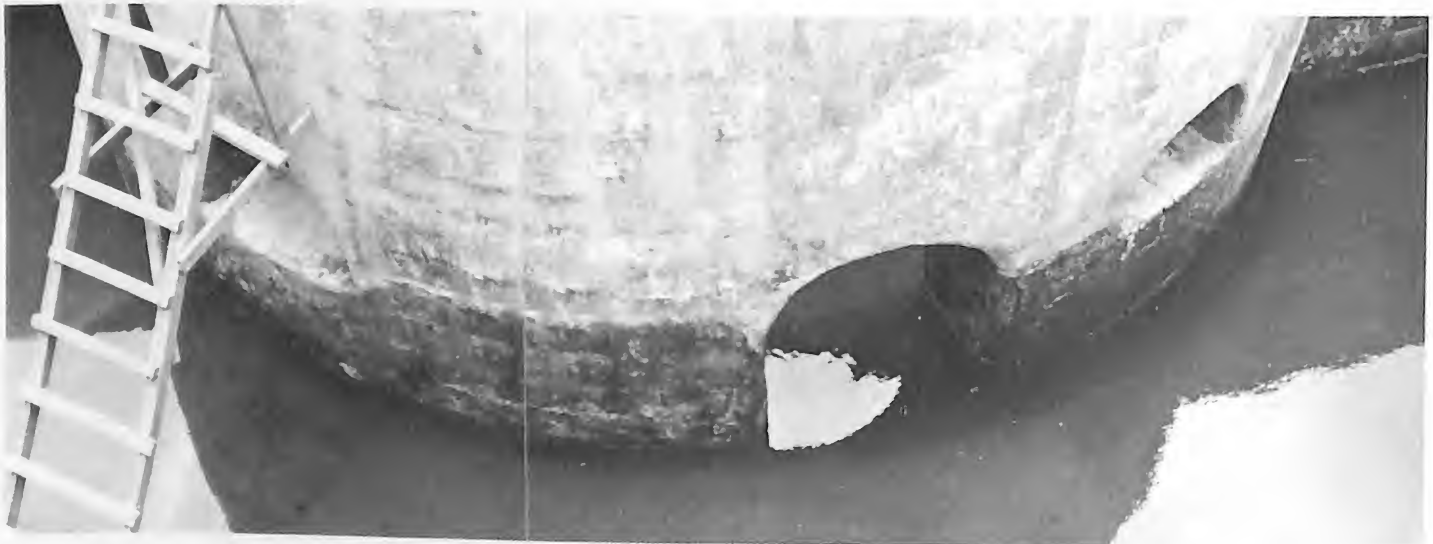
Figure 55. The exterior wall of the first circle showing the water mark indicating how high the water rises.

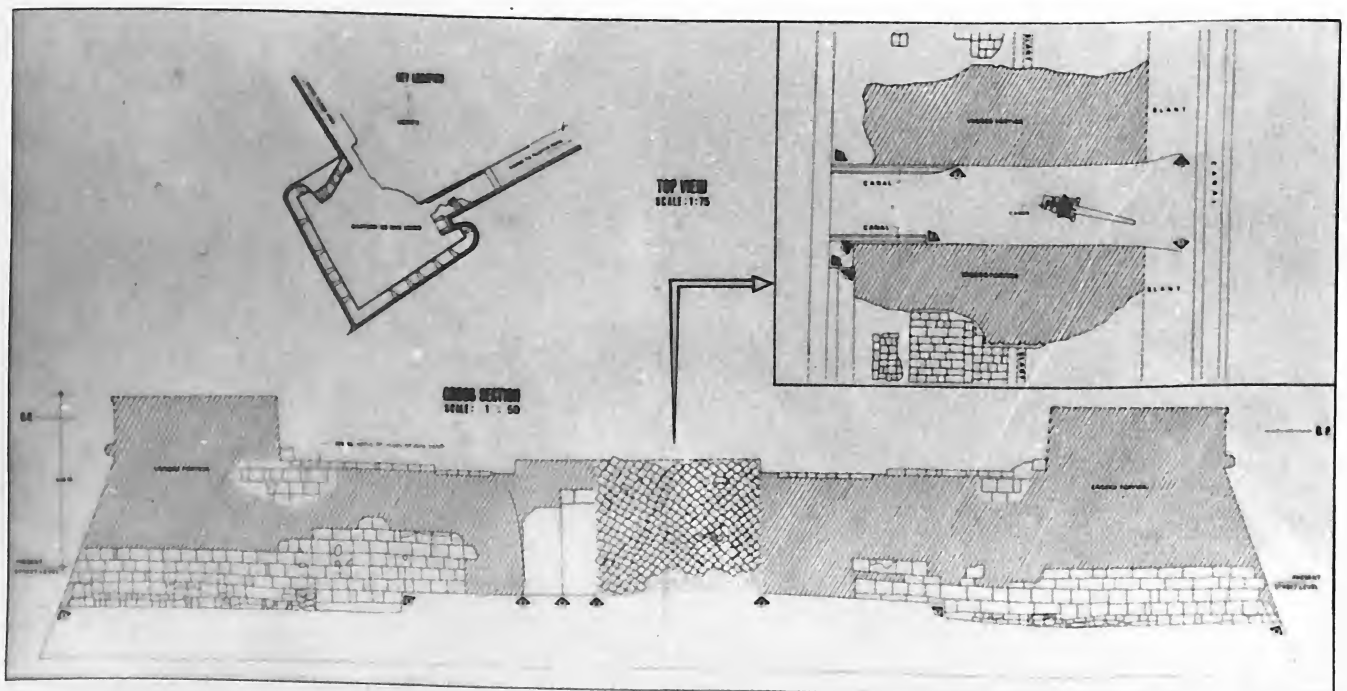
Photograph shows the condition of the west flank. The central portion of the drawing shows how mojonas—landmarks—were used to shore up eroding portion of the wall.

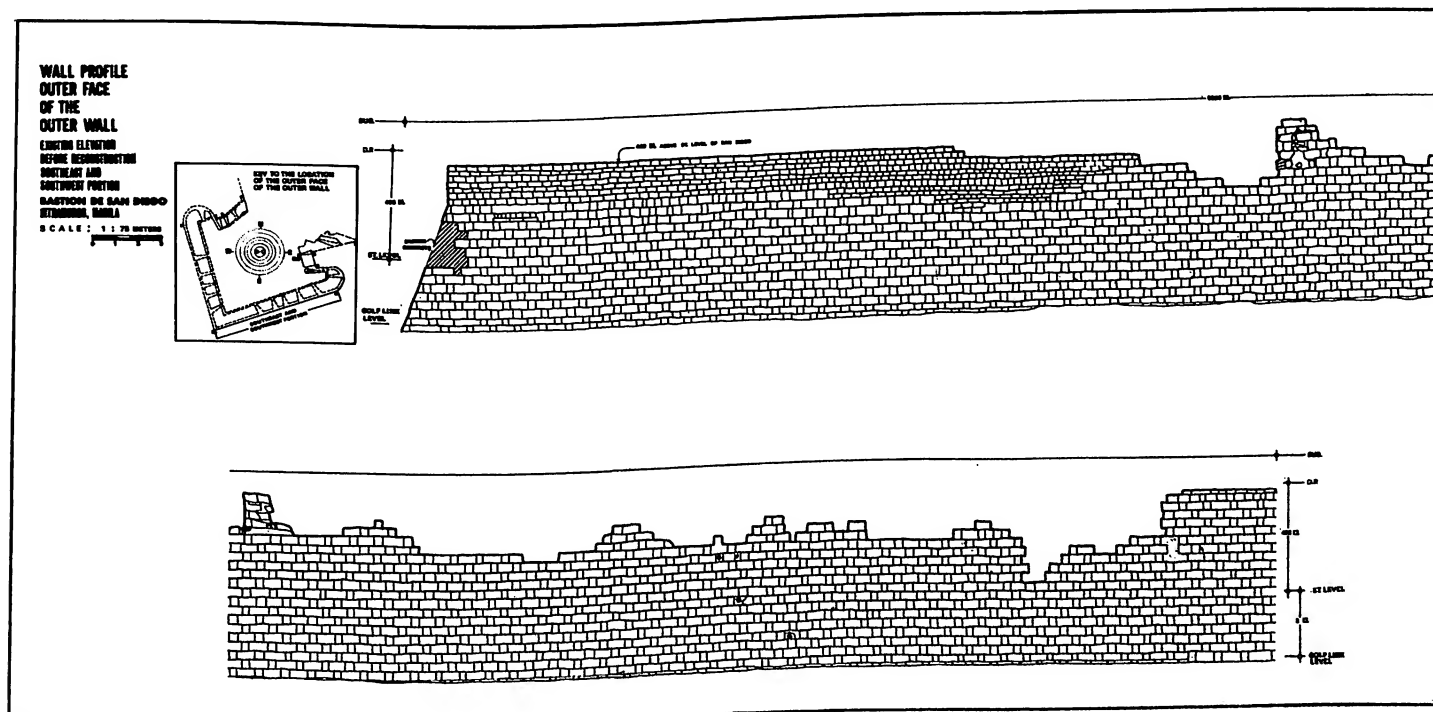
The existing elevation and status of the wall before reconstruction of the southeast and southwest portions.
